EFFLORESCENCE

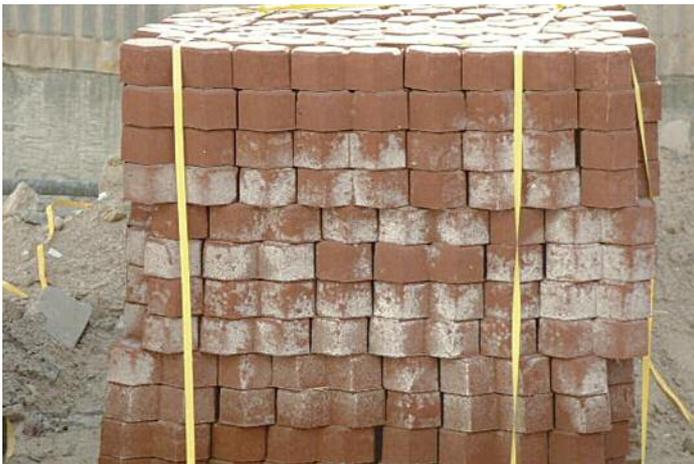
Fig.1

The body of the hardening concrete contains a solution of calcium hydroxide which migrates to the surface through these capillaries. At the surface the calcium hydroxide reacts with carbon dioxide in the air to form calcium carbonate leaving a thin white surface layer (see fig.1). The effect is much more noticeable in damp conditions which cause the calcium hydroxide to spread out over the surface before it is converted into calcium carbonate. In dry conditions it only forms at the mouth of the pores and is much less noticeable. In both cases the effect takes place during the primary hardening of the concrete, say within the first three days. Over this period the calcium carbonate builds up to such an extent that the pores are blocked and the process stops.

In order for cement to harden it requires a certain proportion of water. However the amount of water needed is quite small and certainly not enough to produce a mix that would flow freely into a mould. Block making plants use a semi dry mix with a water cement ratio of about 0.3, but even this means that surplus water has been used. As the cement hardens, this surplus water escapes to the surface creating a network of fine capillaries.
